WHITE PAPER | TAMCO DAMPER BLADES

Adjacent Blade Alignment

Dane Carey, Director of Engineering | JULY 2021

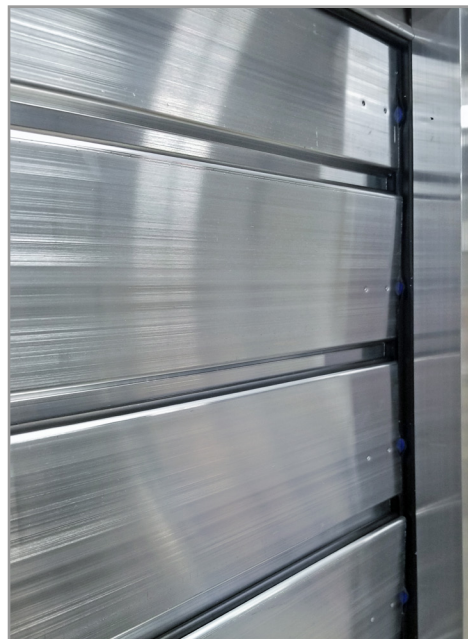
- very tall, over 1220 mm (48”).
- such that the misaligned blades are adjacent to the drive blade.
- constructed with opposed blades (not parallel).
- Series 1000 or 1500. The misalignment is more easily visible with non-insulated air-foil blades than with insulated blades used for Series 9000 or 9000 BF.

Because parallel blades rotate in the same direction, each blade rests against the adjacent blade when in the full closed position. This applies a fairly even force across all blades, pushing the blades to sit flat relative to each other. Since opposed blades rotate towards each other, the tips are traveling in the same direction as they come to the full closed position. When the blade tips meet, there is no opposing force from the adjacent blades. As a result, the blades adjacent to the drive blade can be forced to over rotate and give the appearance of not sitting flat. This can happen when a heavy-duty actuator is installed on a damper, exerting a lot of spring tension on the drive blade while the damper is fully closed. The drive blade compresses the blade seals to the point that the drive blade forces the adjacent blades to appear slightly out of parallel.

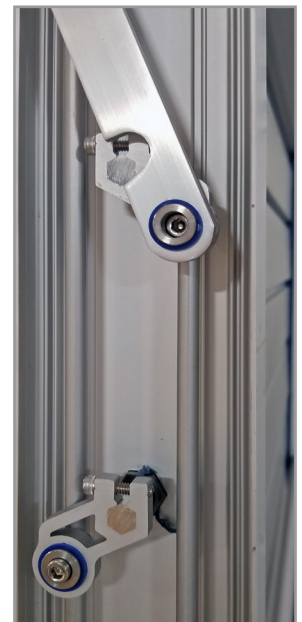
TAMCO linkage

TAMCO damper linkages are unique in the industry, as they can be factory-adjusted so the damper blades close completely, thereby ensuring a very tight seal. Sometimes when extrusion dies are new and the clearances are at their greatest, TAMCO's Quality Control personnel are able to over rotate a blade at the top or bottom of the damper while conducting the light box test and verifying that there are no light lines visible between blades. If required, over rotation of the top or bottom blade helps to ensure a tight seal. Other manufacturers do not produce dampers with adjustable linkage and as a result ship dampers that leak more.

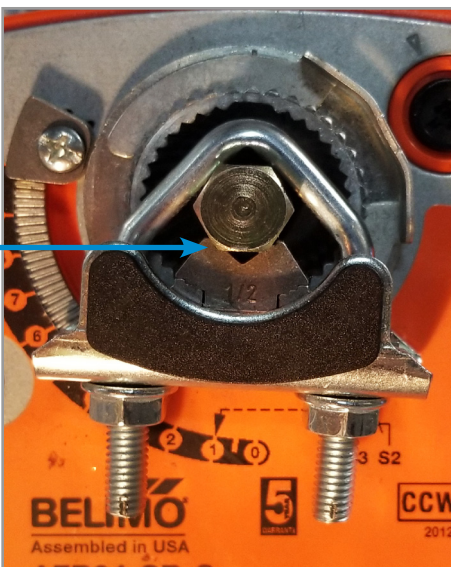
ACCEPTABLE ALIGNMENT

Acceptable if a minimum torque of 9 N-m (80 in-lbs) is applied to tighten the U-bolt nuts.

3. Verify actuator installation. The actuator may not be installed correctly. It may not be providing enough force to close all of the blades tightly, or may be providing too much closing force. The simple remedy to correct this is to adjust the actuator. When setting up the actuator, be sure to open the damper blades and actuator completely, before fastening the actuator to the control shaft. Also, make sure that two of the flat surfaces of TAMCO's hex-shaped control shaft lie flat within in the machined groove of the actuator clamping mechanism. Tighten the clamp and allow the actuator to close the damper. This usually corrects any light (leakage) issues.

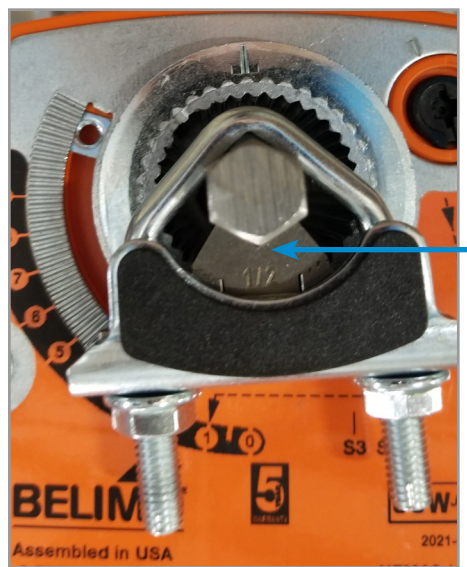
IDEAL ALIGNMENT

This alignment may cause the 0 to 9 position indicator not to read correctly.
