Case Study: The Fox Plaza

San Francisco, California

Summary

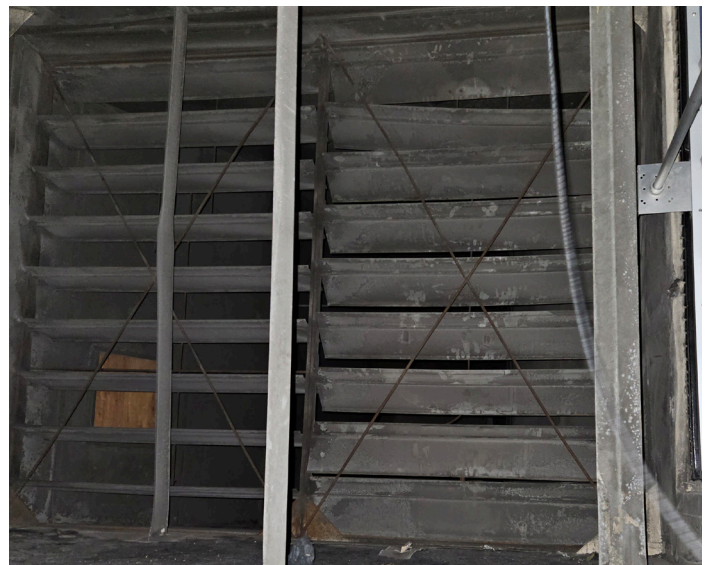
"The galvanized steel dampers corroded to the point where they couldn't move the blades so they would lock them in a minimum position or one way or the other. You end up wasting energy and losing the opportunity for free cooling throughout the day." As Doug spoke on the issue, it became clear the dampers were no longer able to move preventing them from doing their primary task – regulating airflow. Jedidiah also explained the importance of damper functionality. "We should be able to go to the computer, click the button and the dampers do what they're supposed to do. We shouldn't have to go out in the field and wrench on them just to get them to move."

Fox Plaza's previous dampers were visibly inoperable - photo by Doug Miller

Doug recognized a solution to the Fox Plaza problem – **TAMCO dampers**. Doug and Jedidiah worked together to establish a plan. They would replace the currently seized and rusted galvanized steel dampers with TAMCO extruded aluminum dampers, section by section, starting with the worst areas. This was one of Jedidiah's goals for the Fox Plaza, *"It's been a point of interest for me since I took over here as chief engineer, getting the antiquated dampers squared away."*

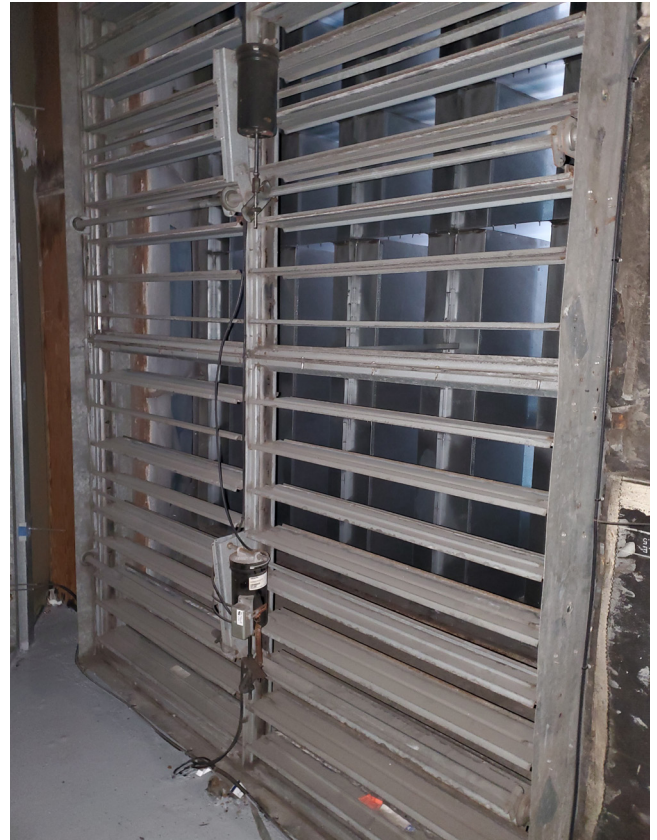
When asked about the most pressing challenges presented by replacing the dampers within a 60-year-old building, Doug mentioned the fog. *"Every single morning San Francisco has bay fog that is very moist and very salty along with the dirt, pollen grime, grit that's in the air that just gets caked on everything. When they built these buildings, the dampers they put in were 'value engineered' galvanized steel and everything was metal-to-metal contact, and it is just is a failure place that rusts and seizes up"*.

Galvanized steel rusts over time resulting in damper failure- photo by Doug Miller

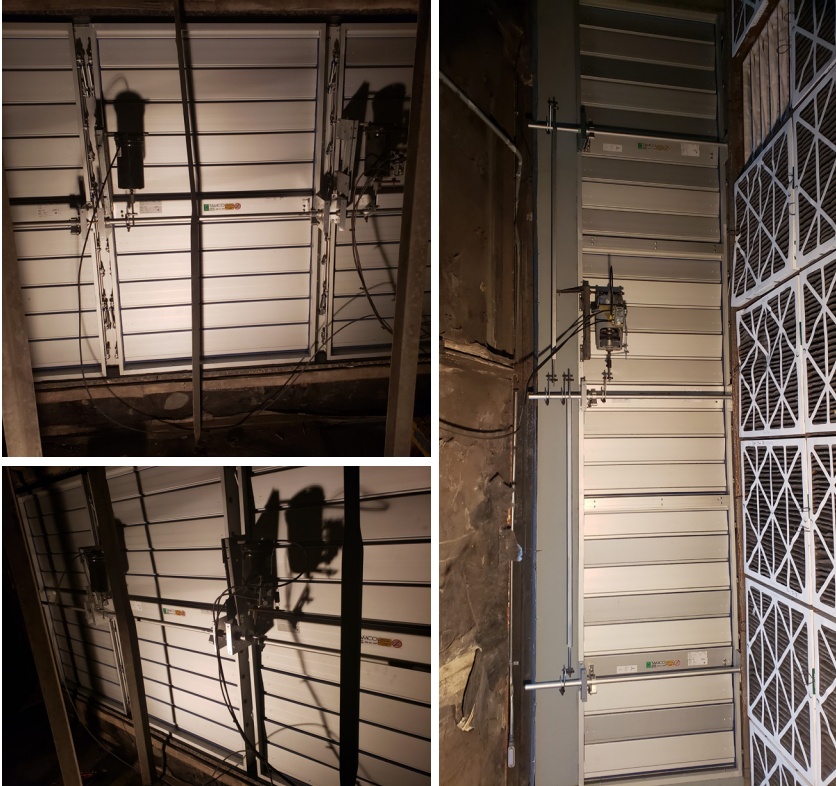
TAMCO Series 1000 Saltwater option dampers were installed throughout the Fox Plaza - photo by Doug Miller

To combat the ever-present environmental challenges, Doug specified the TAMCO Saltwater Resistance option - aluminum dampers specifically designed for coastal climates with stainless steel components, and clear anodized frames and blades. This option helps prevent rust and corrosion where a galvanized steel damper would rust and seize. *“I use the series 1000 Saltwater Resistance option almost exclusively in the Bay Area. I have a few buildings that are on their way to being 100% TAMCO dampers.”*

Having a functional damper with preventive environmental protection allowed Jedidiah to eliminate monthly damper maintenance. *“We were doing a monthly PM that took anywhere from 2-4 hours to complete on all of the dampers to check and ensure they’re modulating properly, they’re cleaned up, and lubricated.”* Jedidiah also explained that replacing malfunctioning linkage was no rare occurrence. A similar sentiment was expressed by Doug *“our competitor’s aluminum dampers typically utilize the same linkage systems that are used on their galvanized dampers, so while the blades and frames may be aluminum, the linkage systems corrode and lock up with a very similar frequency as the galvanized dampers.”*
