# WHITE PAPER | SILICONE JAMB SEALS - 2022 UPDATE

Longevity & Performance at 2,000,000 Cycles

Dane Carey, Director of Engineering | MARCH 2022

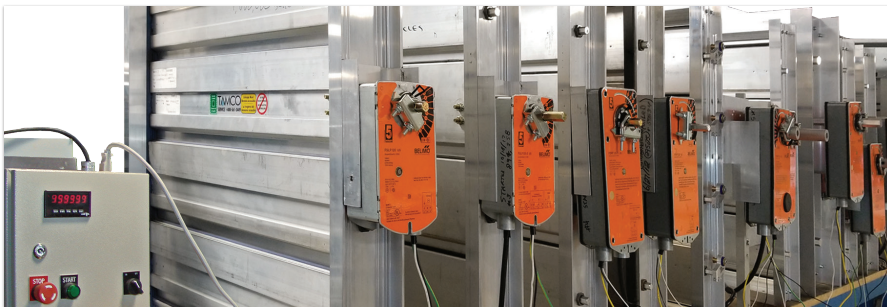
*The actuators installed on each damper were connected to a timed electronic cycler.*

This study originated during the Underwriter Laboratories (UL) certification process for TAMCO's Series 1000 SM, UL/ULC Approved Smoke Damper. Cycle testing simulated normal wear and tear under fair to good conditions in a clean air environment.

Prior to cycling, a leakage test was conducted for all the test dampers, to establish base point leakage rates. Leakage was tested with airflow in both directions. Leakage tests were then conducted at 30,000 cycle intervals, and the dampers were inspected for physical signs of wear and damage. Changes in leakage rates at each cycle interval were compared to base test results.

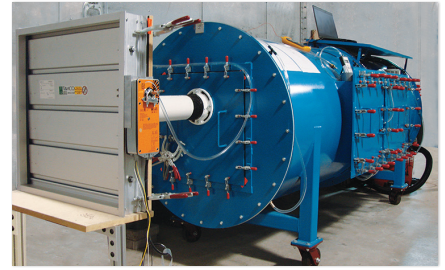
*TAMCO Leakage Test Chamber*

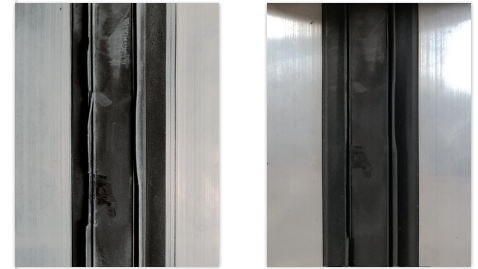
Series 1000 OB

Appearance of damper seals after cycle testing

1 million cycles

2 million cycles

After simulating 1000 years of use, both dampers' leakage rates stayed well below AMCA's maximum allowable leakage rate for Class 1A certification. The jamb seals' fingers were worn in a few places, and did have several superficial tears. However, none of the jamb seals were perforated or torn through. The entire length of each seal remained intact and firmly secured within the channels in the frame extrusions. After 2 million cycles, there was no significant change in the appearance and performance of the jamb seals. Remarkably the leakage rates remained well within AMCA's Class 1A certification.

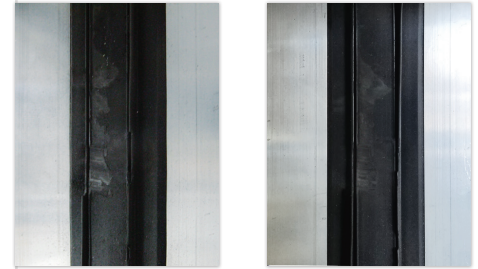
Series 1000 PB

1 million cycles

2 million cycles

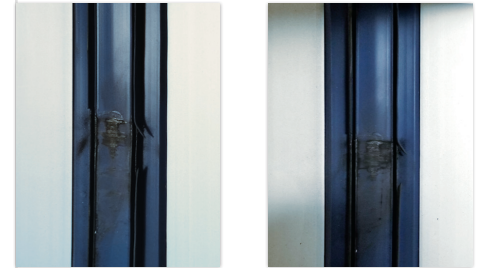
Series 1000 SW assembled out of square

Appearance of damper seals after cycle testing

1 million cycles

2 million cycles

This test damper's frame was forced out of square to simulate a "worst case" condition. Being out-of-square caused only a portion of each blade edge to come into contact with the jamb seal. All of the force that would have been distributed evenly across the entire blade edge was concentrated in a much smaller contact area, effectively increasing the friction applied to the jamb seals.

The images to the right shows the jamb seals of this damper after 1 million and 2 million cycles. Even under these extreme conditions, the seals held fast within the integral slots in the aluminum frame extrusion. None of the seals were torn away. The only changes in appearance observed, were a number of surface tears in the jamb seal fingers, with little discernible change between 1 and 2 million cycles.
